2008 Annual Inspection for the Gunnison, Colorado, UMTRCA Title I Disposal Site

Summary

The Gunnison, Colorado, Disposal Site, inspected on June 3, 2008, is in excellent condition. Fence strands were broken in several locations due to significant snow accumulations during the past winter. Several perimeter signs had substantial bullet hole damage and one sign was missing. The fence was repaired, and the damaged and missing signs were replaced on June 19, 2008. Six riprap test areas on the cell apron and diversion ditches were visually inspected; no apparent rock degradation was noted when compared to photos taken in 2007. Snowmelt runoff resulted in minor erosion near the southeast corner of the site. No cause for a follow-up inspection was identified.

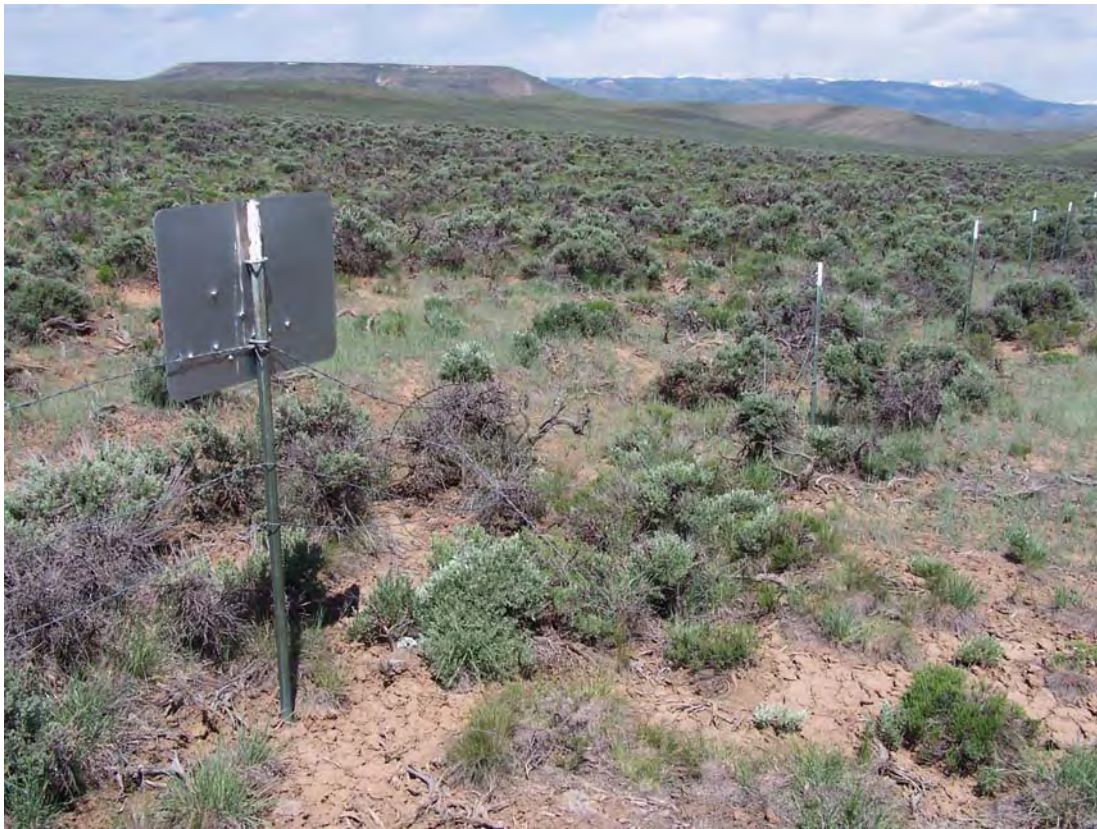
A 3-strand, barbed-wire fence encompasses the site, and most of it is set along the property boundary. Fence strands were broken at several locations along the north and west sides of the site (PL-1). This damage is attributable to the above-average snow accumulation that occurred during the past winter. The broken strands subsequently were repaired on June 19, 2008. The south entrance gate is a barbed-wire gate with a DOE lock. Two other locked barbed-wire gates—one on the north fence line and the other on the east fence line—provide monitor well access. The gates were locked and are in excellent condition.

GUN 5/2008. PL-1. Broken fence strands near perimeter sign P8.

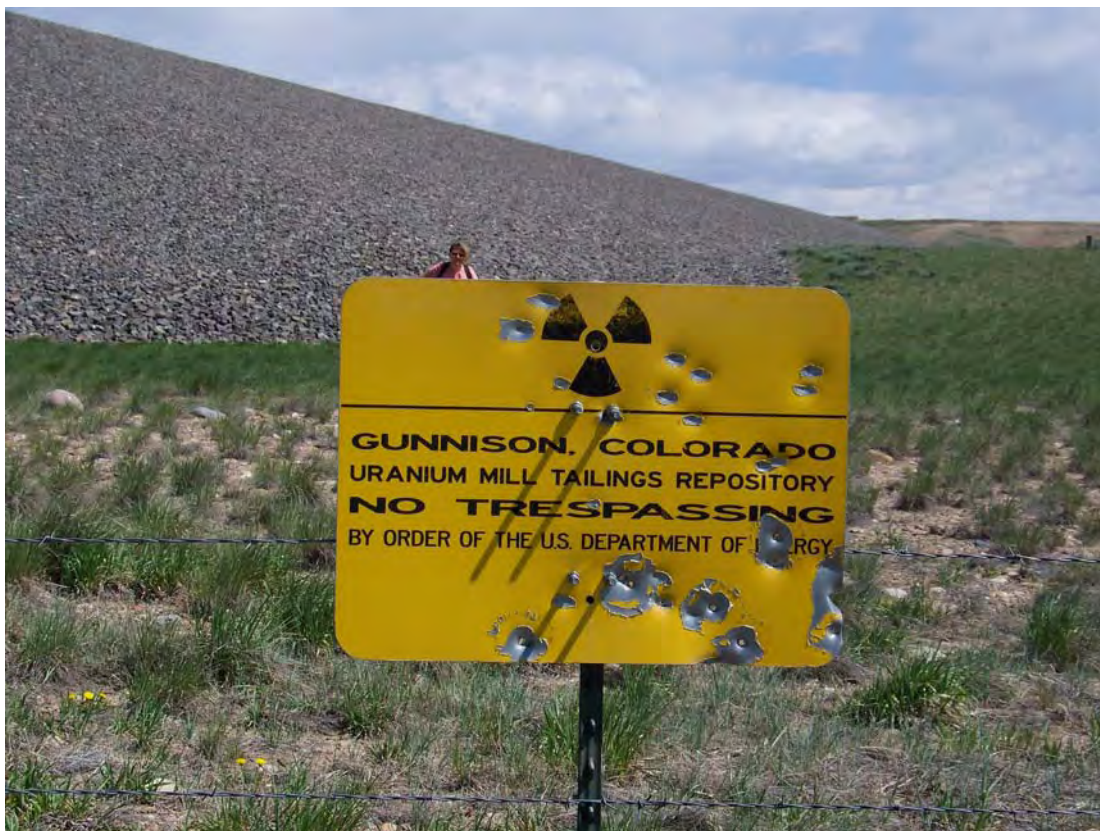
The entrance sign, located at the south entrance gate, is in good condition. Forty-five perimeter signs are bolted to the perimeter fence posts. Nine perimeter signs were heavily damaged by bullets (PL-2) and one sign was missing; new signs were installed at these locations on June 19, 2008. The remaining signs are in good condition.

GUN 5/2008. PL-2. Damaged perimeter sign P42.

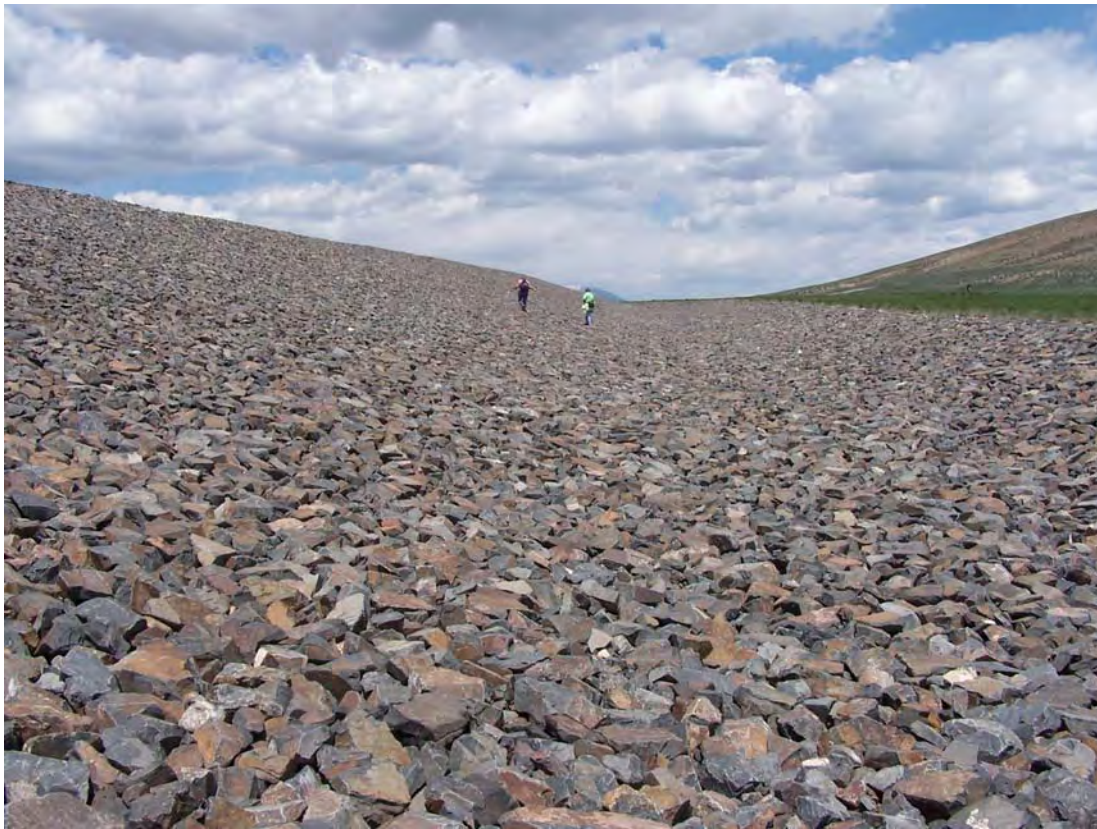
The riprap-covered side slopes, apron, and diversion ditches also are in excellent condition (PL-3, PL-4, and PL-5). No evidence of slumping, settling, rock degradation, or encroachment of vegetation was observed.

GUN 5/2008. PL-3. East diversion channel along the northeast side of the disposal cell.

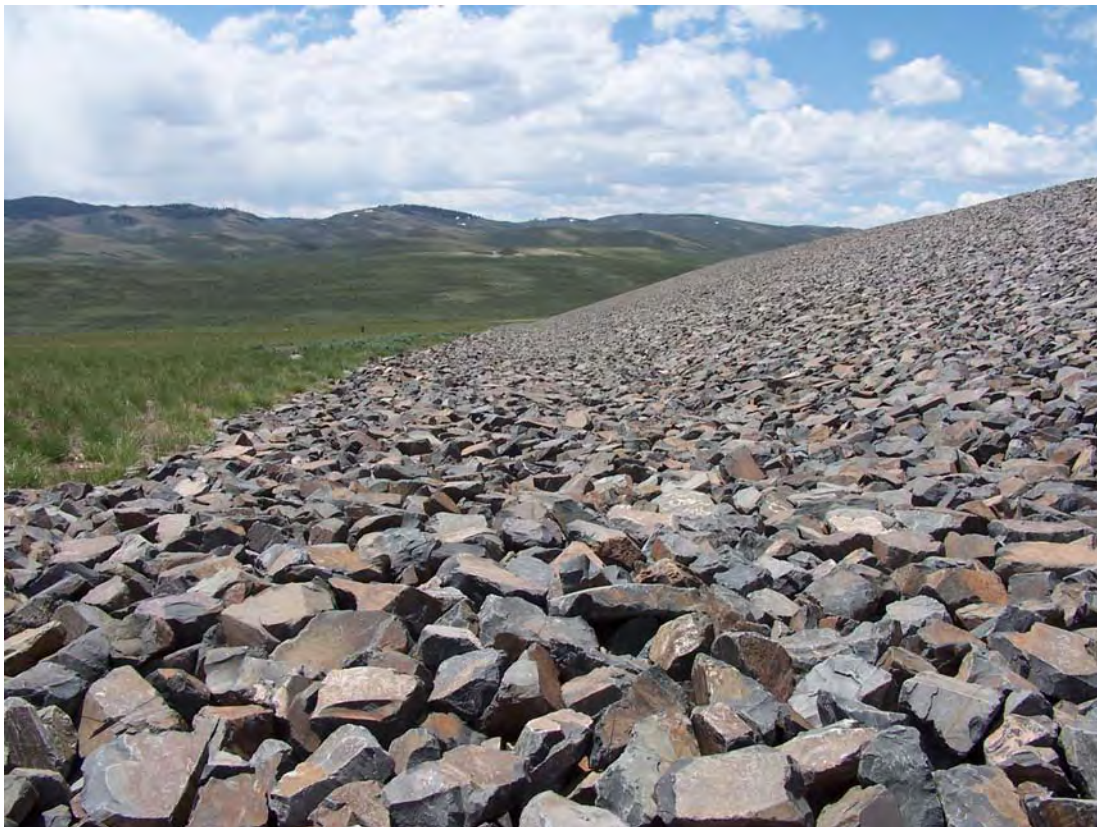
GUN 5/2008. PL-4. Southeast side slope of the disposal cell.

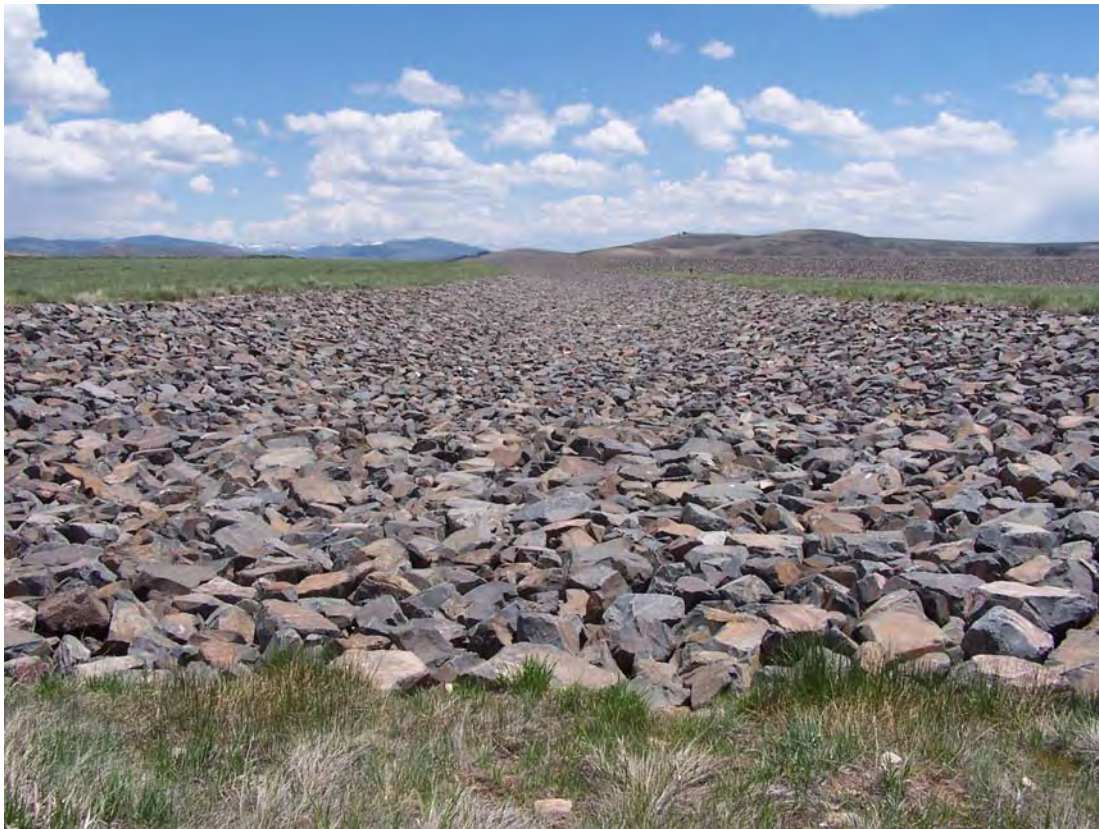
GUN 5/2008. PL-5. West diversion channel.

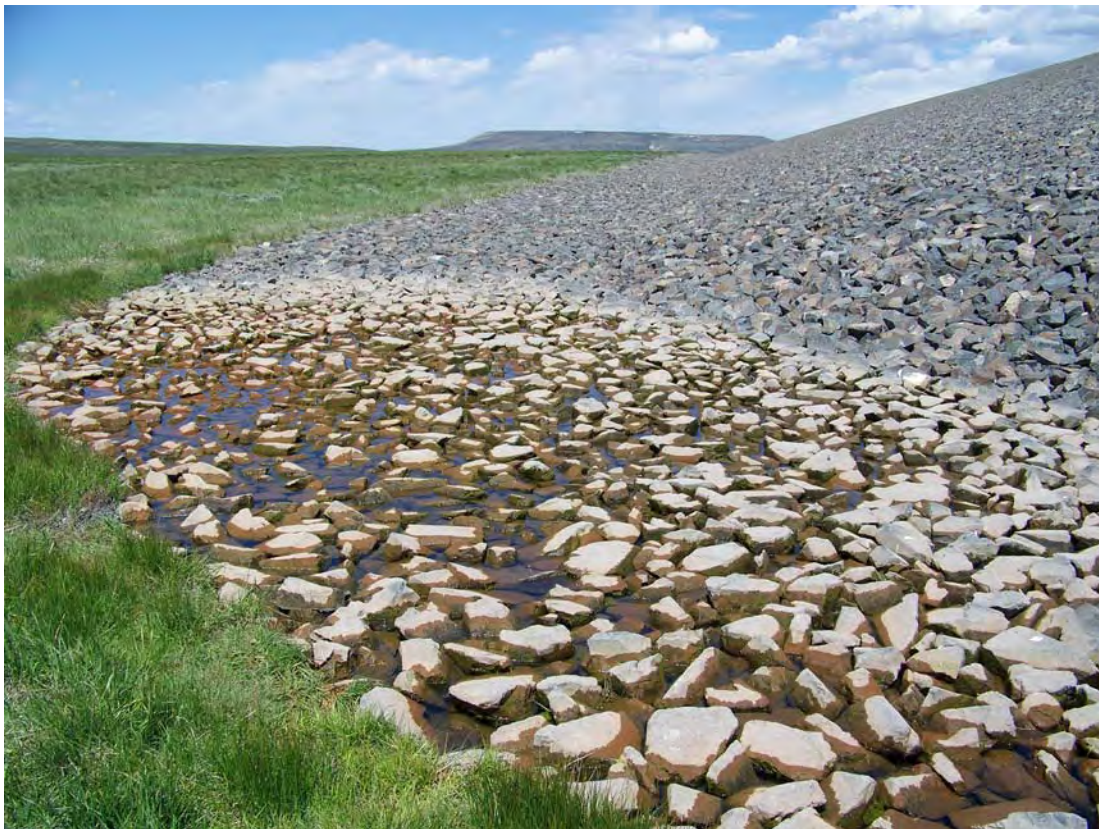
At the southeast corner of the cell apron, water draining from the cell occasionally ponds in a low-lying area along the edge of the riprap. The riparian-type vegetation that has become established in this area indicates that the area retains moisture much of the time. Water collection in this area does not pose a problem because the cell is designed to drain to the southeast, and any water that ponds is below the elevation of the footprint of the tailings. Ponded water was present in the apron (PL-6) and the soil in this area was moist at the time of the inspection.

GUN 5/2008. PL-6. Ponded water at the southeast corner of the disposal cell.

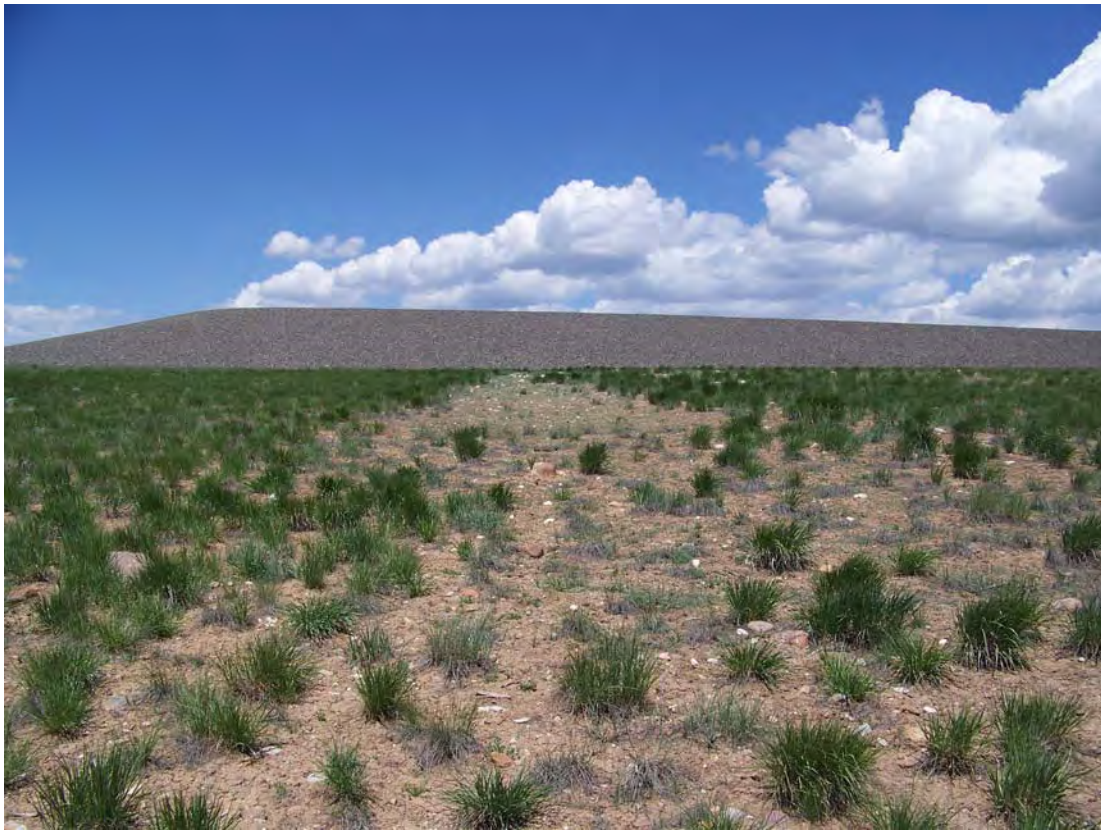
Reclaimed and undisturbed areas occur between the disposal cell and the site perimeter. Both types of areas are in excellent condition. In general, reclaimed areas have good coverage of vegetation, mostly grass. However, there are several small areas of sparse vegetation attributable to poor soil conditions (PL-7). Shrub and forb abundance and diversity are much less in reclaimed areas than in undisturbed areas. Overall, however, the vegetation at the site is very healthy following a winter of above-average snowfall.

GUN 5/2008. PL-7. Poorly vegetated area near the east side of the disposal cell.

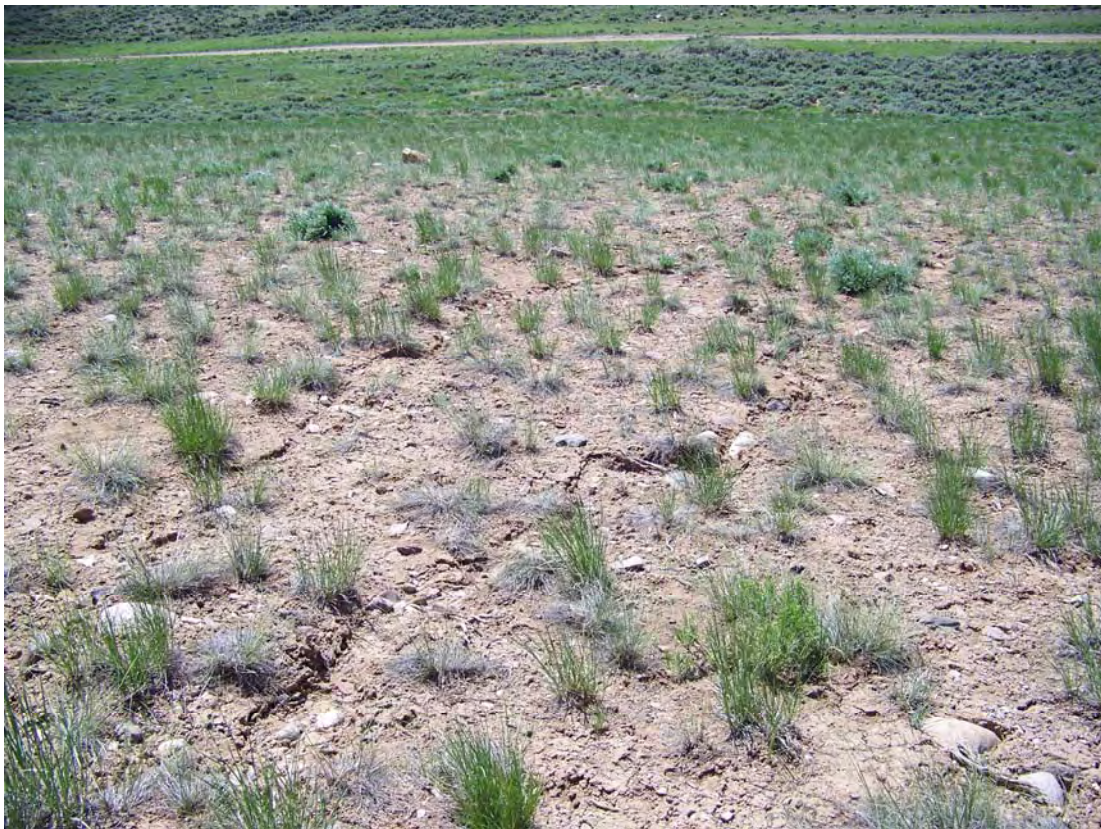
Several locations in areas of steep topography had been susceptible to erosion in the past. Snowmelt runoff caused minor rill erosion and sediment deposition at a location near the southeast corner of the site (PL-8). No erosion control is necessary at this time and the area is expected to stabilize; however, this area will continue to be monitored. All other areas were stable with no evidence of new erosion.

GUN 5/2008. PL-8. Erosion area near the southeast corner of the site.
